Subject: Lane B & C Truck Scale Condition Report

Lane C Weigh-Tronix Truck Scale

Lane B Weigh-Tronix Truck Scale

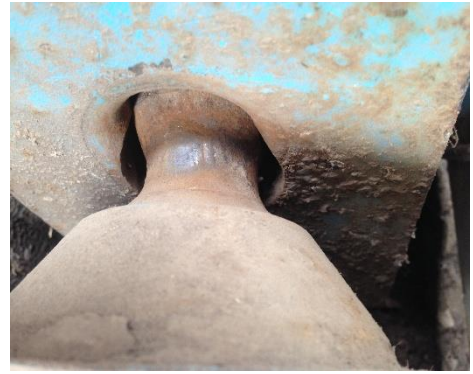
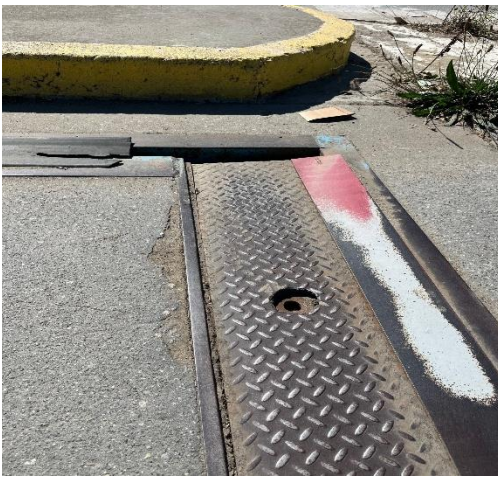
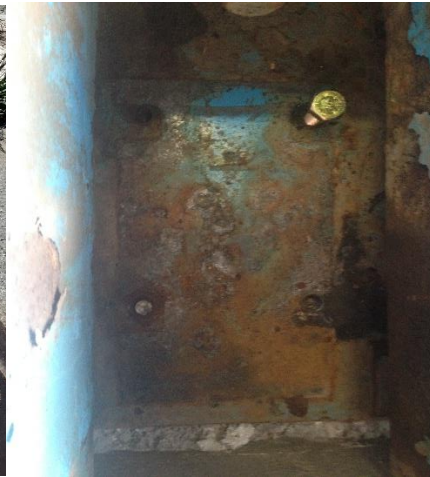
- Suspension is excessively worn.
- Structure of deck starting to develop weak points.
- Broken deck lid hardware

This scale is in better shape than Lane C scale. There are still noticeable signs of wear. These scales are no longer available, in the case of a stand failure, this can lead to excessive down time and possible decommission of equipment. The corrosion of components is causing bolts to break inside base plate. This makes some of the repairs hard to resolve since the condition of steel has deteriorated due to debris and moisture exposure.

Corrective Action: The scale was calibrated and was left within tolerance.
